Trylon has recently received the Safety Notice from Crosby Group regarding potentially defective 7/8" 6.5t Shackles with the PIC marking "5VJ".

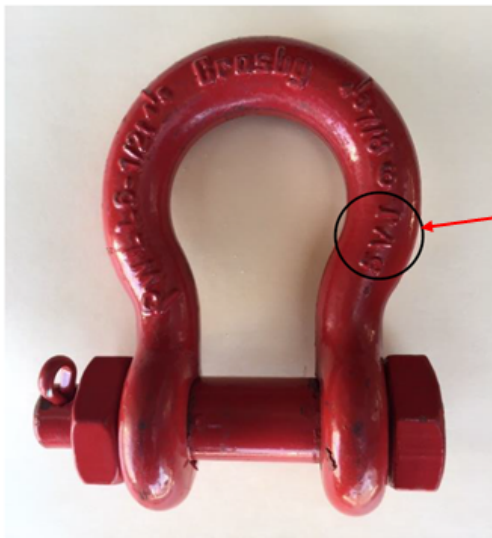
Production Information Code (PIC) Location

Not Acceptable:

7/8" Crosby
Shackles bearing
the PIC marking
"5VJ".

Nonetheless, Trylon has implemented incoming inspections on all Crosby Shackles to prevent any potentially affected product from being received while we work closely with our Supplier to mitigate this risk on their end as well.
